Archaeological investigation of the Lower Karori Dam Spillway, Karori Wildlife Sanctuary

report to
The New Zealand Historic Places Trust,
Karori Wildlife Sanctuary
and
RCP

Date: 22 January 2009

Reference: 2009/25

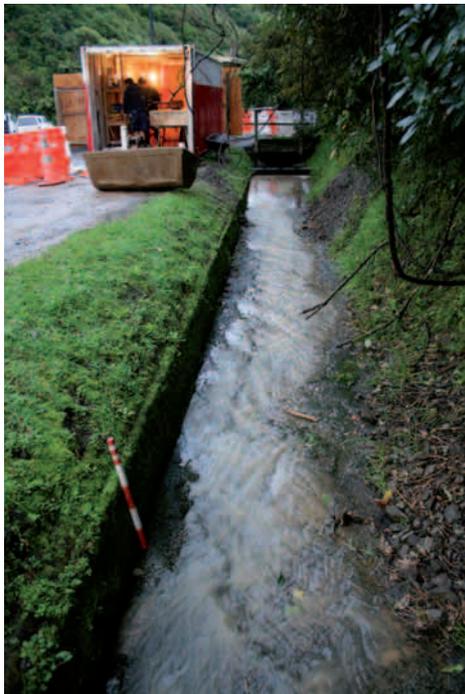
Figure 2. The portion of the spillway at the north end of the development area. The spillway can be seen running under Waiapu Road in the background. Photo taken from location of Cross-Section 1.

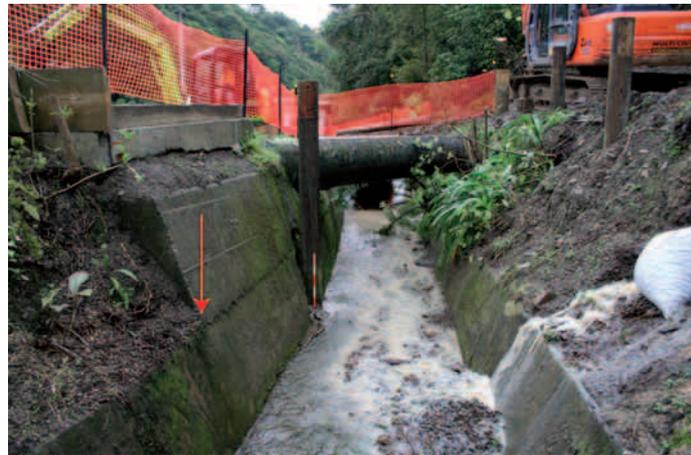
Figure 3. The portion of the spillway at the south end of the development area. Photo looking north towards Waiapu Road. Location of Cross-Section 2 indicated by arrow.

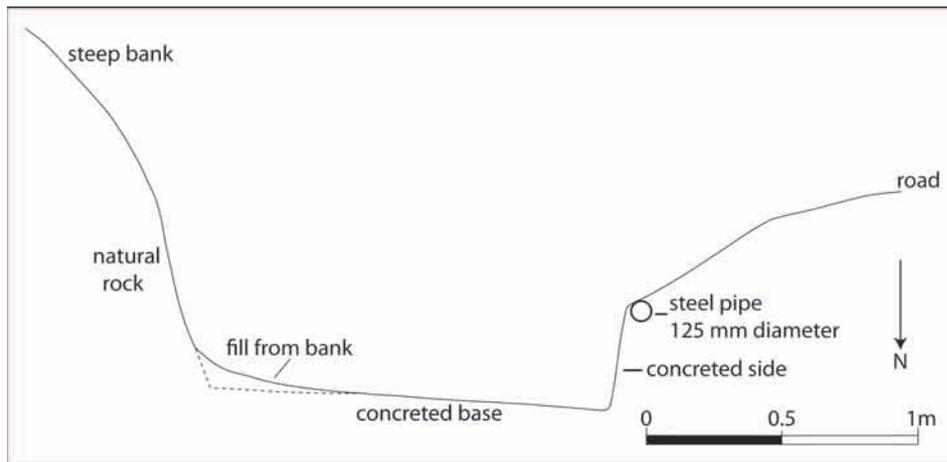
This section of the spillway was then scraped down by hydraulic excavator and the concrete facing removed to determine how the spillway had been constructed. It had been constructed simply by digging a channel down into the natural rock and facing the base and sides where required with concrete. The natural rock can be seen clearly on the east side of the spillway after

Figure 4. Cross-Section 1, taken at the north end of the spillway.

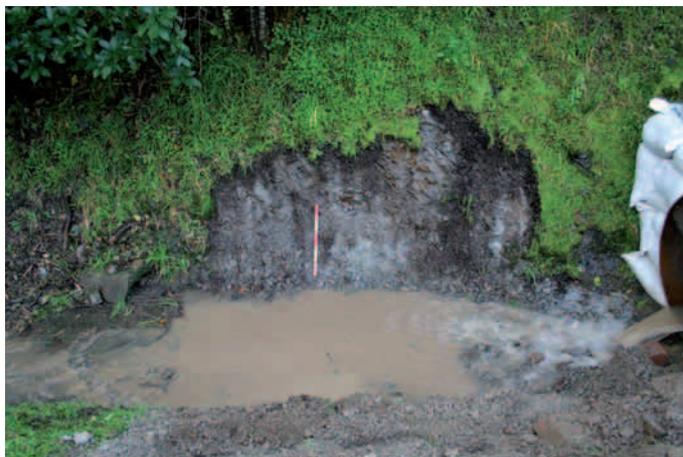
Figure 5. The natural rock bank forming the east side of the spillway channel after machine cleaning.

cleaning back with the machine in Figure 5. The concrete on the base of the spillway had been poured directly onto the natural rock and varied in thickness from less than 100 mm to up to 150 mm. The concrete on the west side had also been poured directly against the bank of the channel. The area immediately to the west of the spillway and running adjacent to it has already been modified as a roadway. No other evidence relating to the dam complex apart from the spillway was noted in this area.

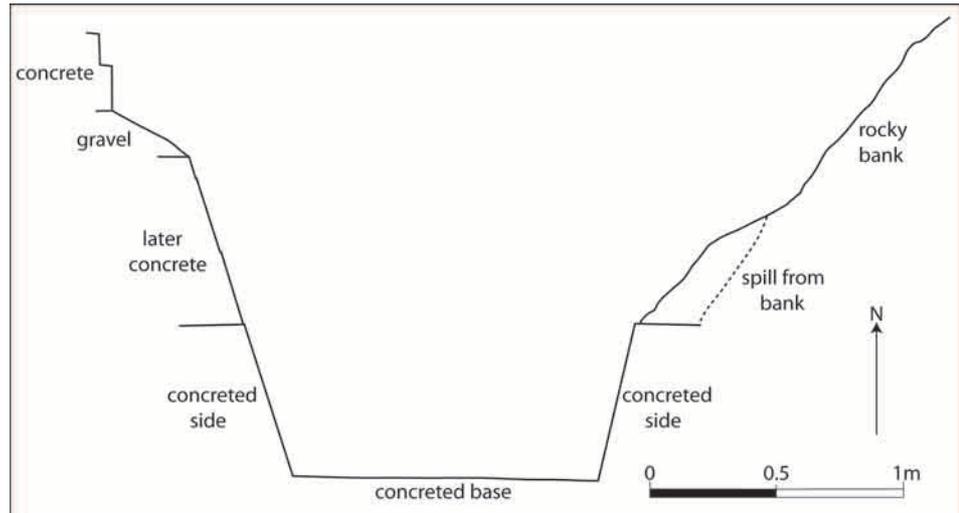
The second section of the spillway was investigated by photography, making a cross-section drawing, and cleaning back sections of the concrete structure by trowel and spade. No further mechanical excavation was undertaken. In this area the spillway is narrower with the base measuring 1200 mm across. This is most likely due to the channel being significantly deeper in this area at up to 1800 mm deep, compared to 750 mm where cross-section one was drawn. The channel is lined on the base and the sides up to a height of 600 mm (Figure 6). The later concrete on the west side of the channel is associated with the large steel water pipe which crosses the spillway, visible in Figure 3. The concrete at the top of the west side is even later still and associated with a walkway over the spillway to the old visitor centre.

Figure 6. Cross-Section 2, taken at the south end of the spillway.

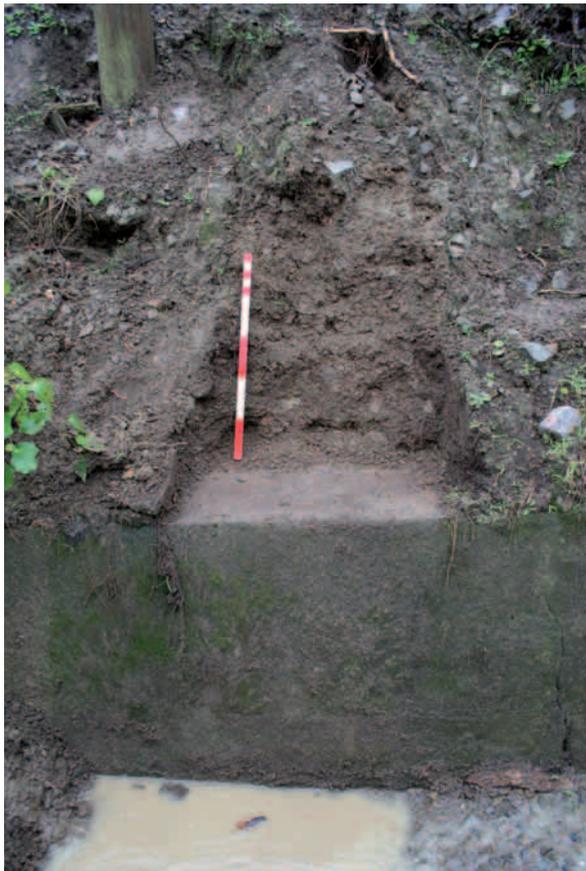
No concrete was removed in this area but a small section on either side of the spillway was exposed by spade and trowel. As can be seen in the cross-section drawing (Figure 4) and in the photos (Figures 7 and 8) the concrete at the top at least is 250 mm thick. The thickness of the

Figure 7. Concrete facing exposed on the east side of the spillway, scale 0.50 m.

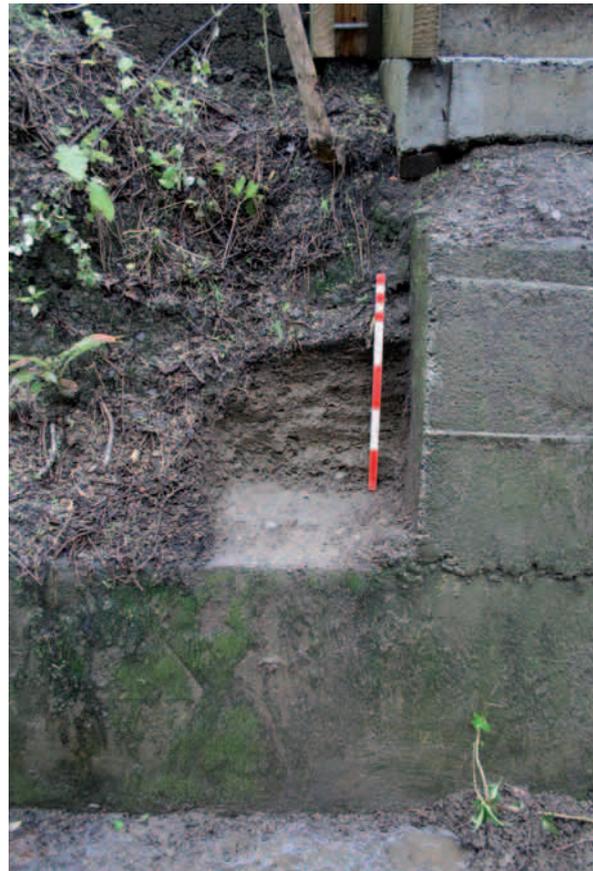
Figure 8. Concrete facing exposed on the west side of the spillway, scale 0.50 m.

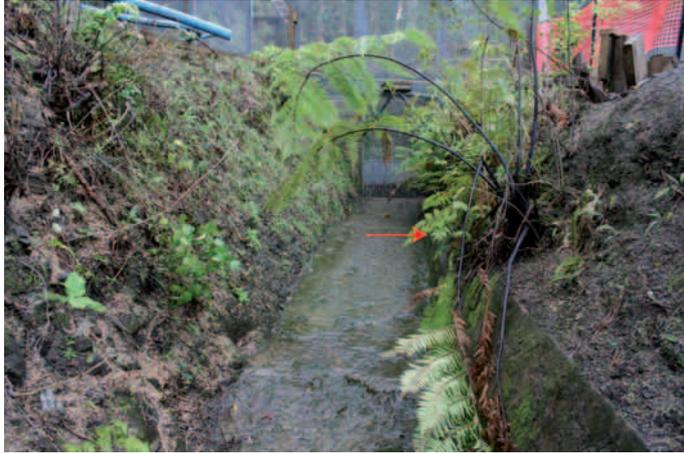
concrete on both the base and sides probably varies greatly, like the section investigated at the north end of the spillway. A few metres back up the valley from where the cross-section was taken the sides are not faced at all (Figure 9). As with the area where the first cross-section was taken the land adjacent to the spillway on the west side has been developed as a roadway. On

Figure 9. The section of spillway south of Cross-Section 2 and immediately below the culvert, clearly showing the natural rock bank forming the east side of the spillway channel. The arrow indicates where the concrete facing ends on the west bank.
