**ARCHAEOLOGICAL MONITORING OF VECTOR
UNDERGROUND CABLES,
HAPIMANA STREET, ORAKEI
(HNZPTA AUTHORITY 2017/590)**

**REPORT TO
HERITAGE NEW ZEALAND POUHERE TAONGA
AND
VECTOR LTD**

Date: 5 September 2017

Reference: 16-0750

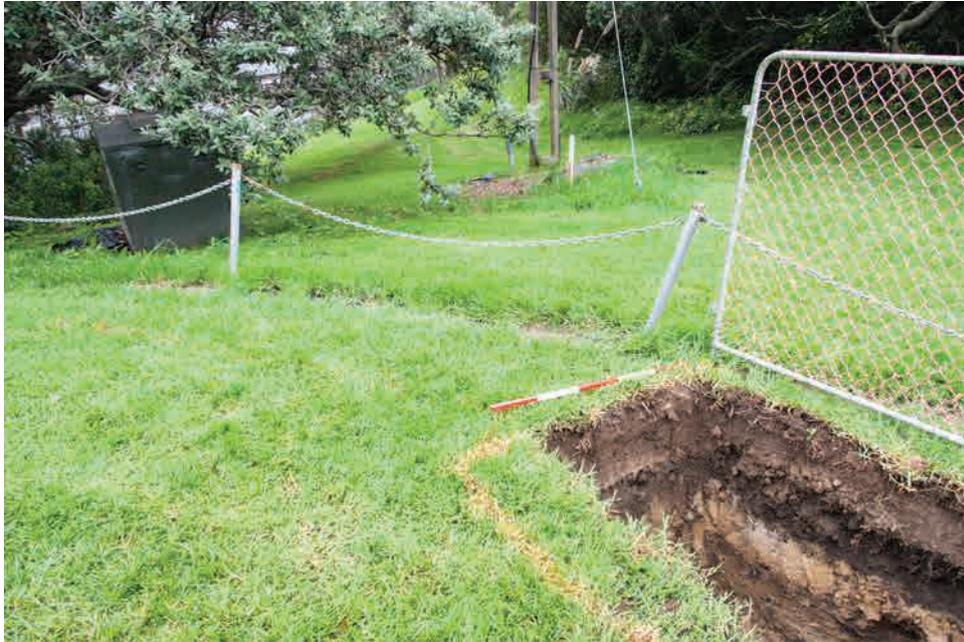
2 (left). Excavation hole for underground drilling entry point at uphill point by the new transformer location, Hapimana Street, view north.

The monitoring of earthworks did not expose any archaeological contexts (Figure 2). The two spoil heaps from 2103 were labelled as "uphill" and "downhill" deposits (Figure 3). Both were sampled for analysis and the remaining material was reinterred onsite. All earthworks were recorded and mapped.

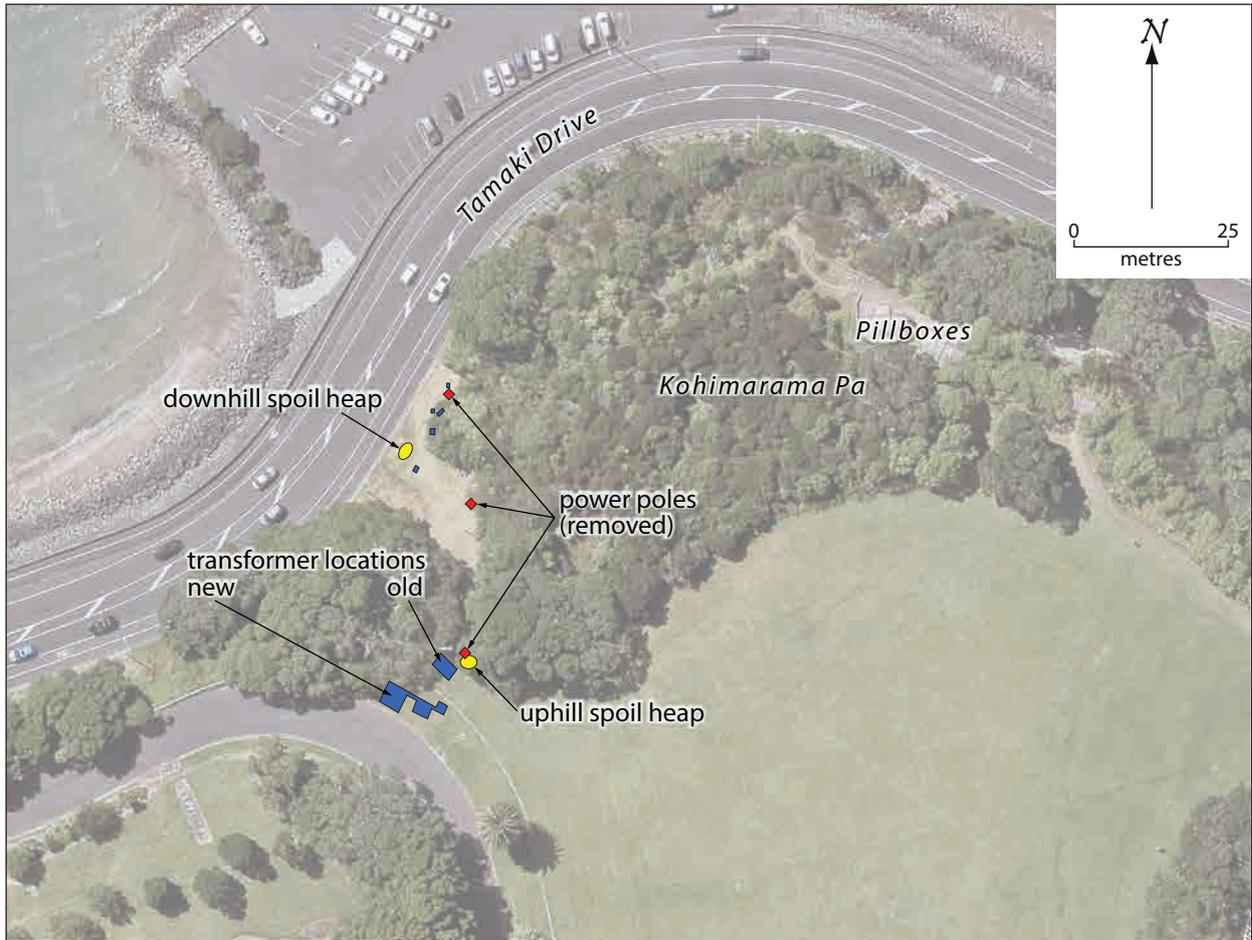
3 (below). The project area showing the extent of earthworks in blue, the two 2013 spoil heap locations in yellow and the removed power poles in red.
