**Archaeological monitoring of Stormwater Upgrade
Works: City Park Services, Kari Street Nursery,
Kari Street, Auckland**

**report to
Auckland City Council**

Date: 25 May 2010

Reference: 2011/2

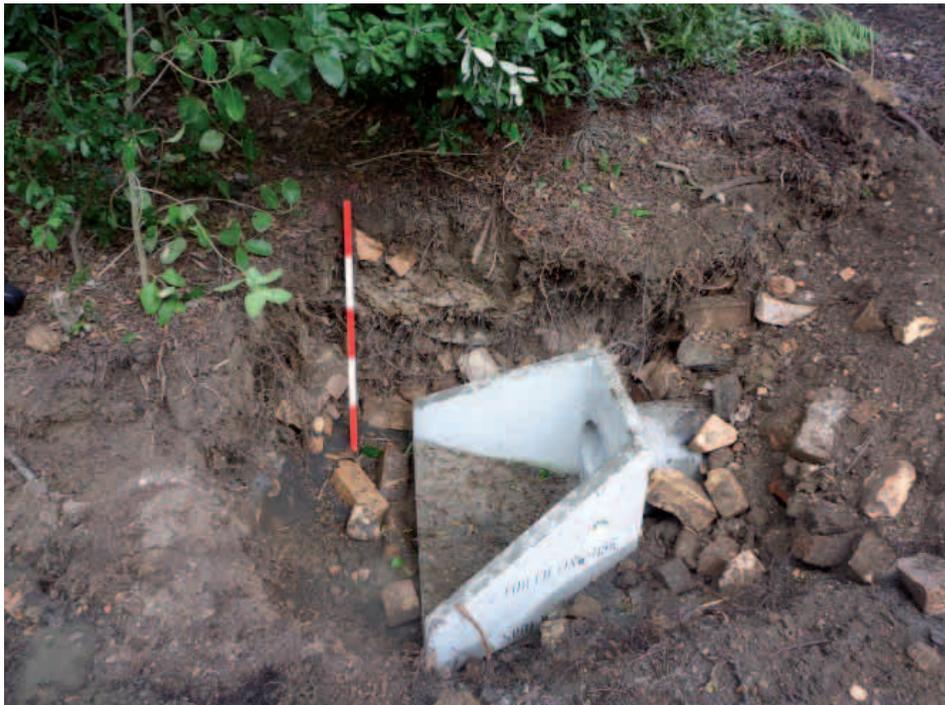
The first excavation was for the installation of a new manhole and catchpit at the head of a small natural gully, which stormwater runoff had previously flowed down uncontrolled. The profile of the excavation revealed a deep layer of fill 1–1.5 m deep, overlying natural blue/grey clay. The fill was made up of mixed clay and soil, with large pieces of concrete and other build-

Figure 1. Brick and concrete building rubble in the profile at the end of the stormwater trench running from the main office (scale 1 m).

ing rubble. A trench was dug from here across the vehicle track to another new catchpit on the other side and the profile was the same.

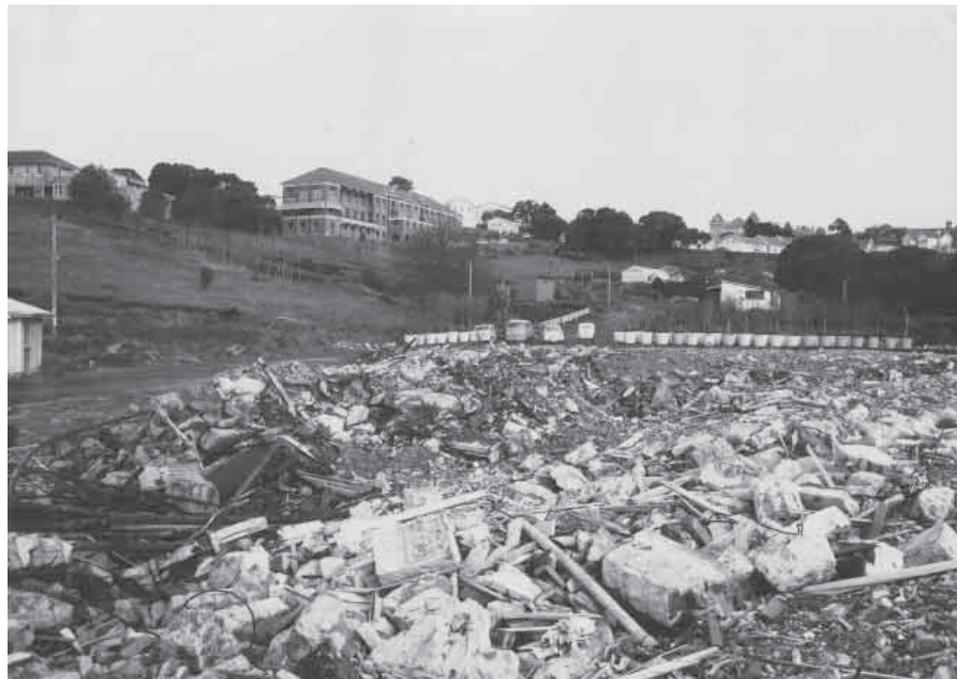
The source of this building material is from the demolition of the old Auckland Hospital Building in 1964 (Figure 2), which means that the levelling of this area occurred at or after this date. The building was designed in an Italianate style by architect Philip Herepath as a replacement for an earlier wooden building and construction began in 1875 (*Daily Southern Cross* 17 May 1875). The new hospital was a substantial three-storied building with the foundations and main part built of bluestone and the lighter partitions of brick (*Daily Southern Cross* 1 September 1875).

Figure 2. Deposition of building rubble from the Auckland Hospital Building, 1964. The corner of the office building where the stormwater trench finished is visible at the far left of the photo. Photo courtesy John Stevenson, City Park Services.
