# ARCHAEOLOGICAL MONITORING AT 350 RICHMOND ROAD, GREY LYNN

**REPORT TO  
THE NEW ZEALAND HISTORIC PLACES TRUST  
AND  
STEPHEN AND SUSAN HIRST**

**HPA AUTHORITY 2012/907**

**JADEN HARRIS**

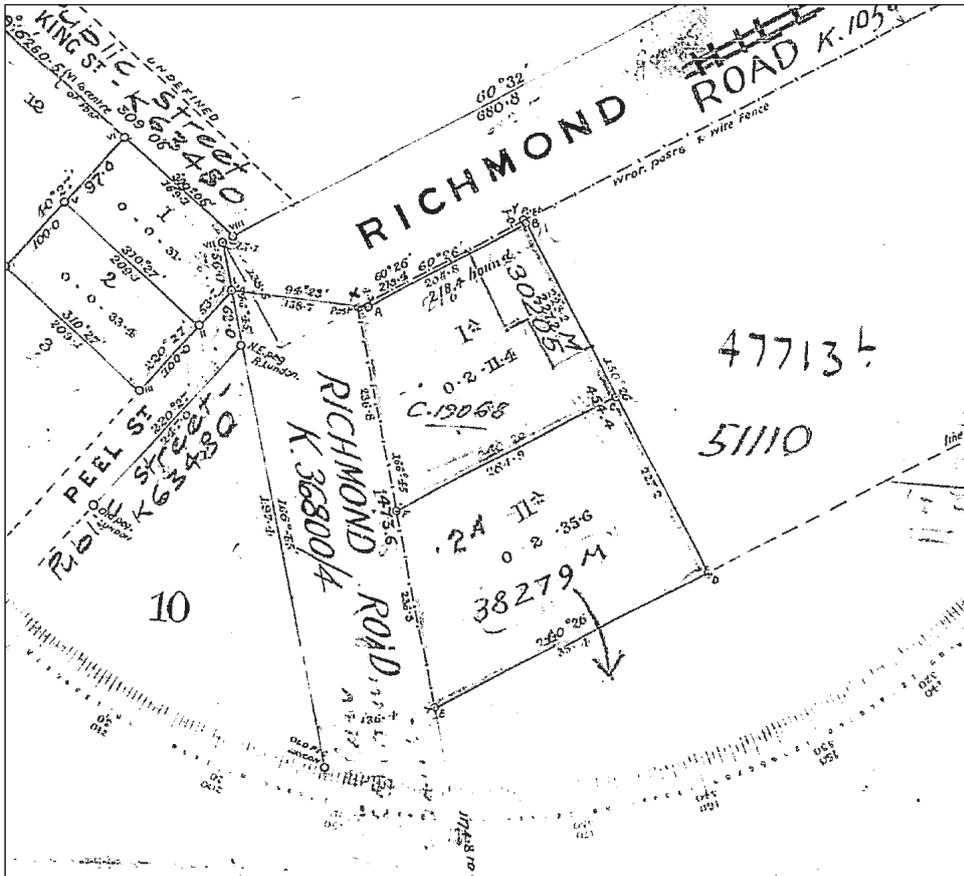
2. Detail of plan DP 938A, surveyed December 1884, showing the subdivision that created the section on which the house at 350 Richmond Road now stands.

The current lot at 350 Richmond Road was originally created by a subdivision of land owned by the Warnocks in 1884. This subdivision created sections 1A (334 Richmond Road) and 2A (350 Richmond Road), being a subdivision of part Allotment 44, Suburban Section 8, Parish of Waitemata (Figure 2). This subdivision was on land purchased by the Warnock Brothers on 6 May 1874 (Table 1). The deed for the sale (28D 335) records that an area of 1 acre, 2 roods and 35 perches, being part of Allotment 43 and 44, Section 8, Suburbs of Auckland, was purchased by James Warnock, William Warnock, Richard Warnock and Robert Taylor Warnock, soap and candle manufacturers, from James Thomas Boylan for the sum of £150. The deed further states that the original Crown Grant for this piece of land was granted to Christie in 1844 who then on sold it in 1846, before it was purchased by Boylan in 1864. It would seem unlikely that there was any development on the land prior to the purchase by the Warnocks in 1874.

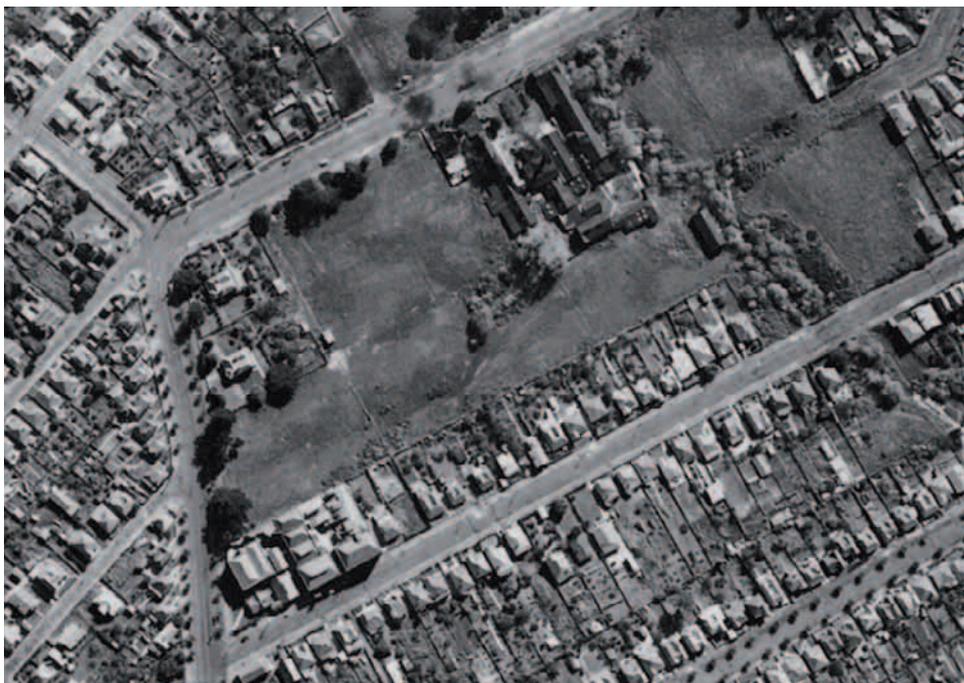
3. 1940 aerial photograph showing the houses at 350 and 334 Richmond Road and Warnock Brothers Factory (<http://maps.aucklandcouncil.govt.nz>).

In the 1940 aerial photograph the layout of the house and gardens at 350 and 334 Richmond Road can clearly be seen, along with Warnock Brothers Soap and Candle Factory beside Cox's Creek (Figure 3). A building at the back of 350 Richmond Road in the paddock may be the original stables but is no longer extant as this area has since been developed.

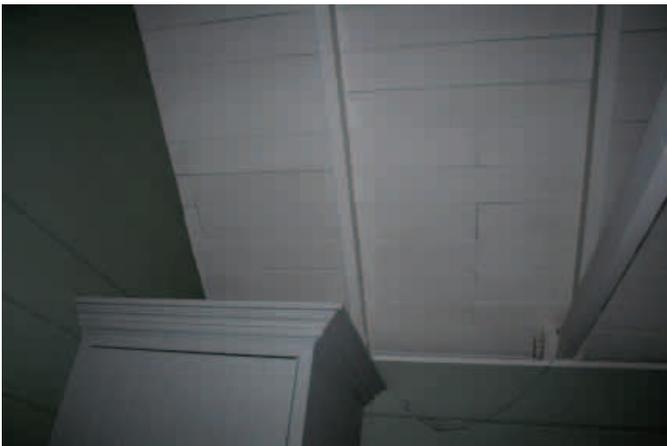
4 (top). Square patch in the ceiling lining in the north-east corner of the main room marking the location of a former chimney.

At this stage the interior of the building was also inspected to check for evidence of any structural or functional modifications. In the main room it was evident that the floorboards in a strip 700 mm wide out from the south wall were later replacements. These replacement boards were much narrower than the 135 mm wide kauri tongue-and-groove boards used in the rest of the structure and were not kauri. Part of the original lining of the south wall below the window had also been replaced with MDF sheeting. Plumbing and electrical fittings suggested that these modifications had been to install kitchen facilities in this area. The exposed sub-floor where the later floorboards had been removed also showed that many of the original joists and bearers had been replaced or repaired with modern treated timber. The original wall lining is 210 mm wide tongue-and-groove kauri match-lining and on the ceiling narrower tongue-and-groove boards have been used, with the roof rafters and beams left exposed. In the north-east corner of the main room the ceiling lining showed a square patch 50 mm out from the internal wall and 1050 mm wide marking the location of a former chimney.

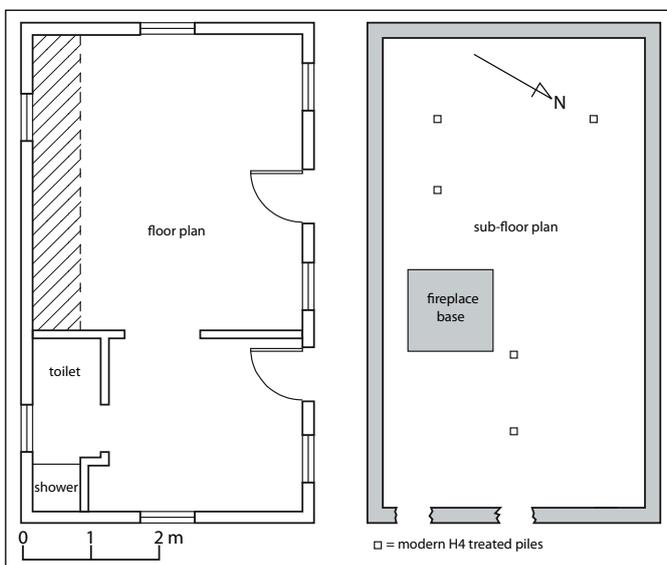
5 (bottom). Left, floor plan and, right, sub-floor plan of the cottage (adapted from plan supplied by Pearson and Associates Architects Ltd).

When the cottage had been shifted off of its original foundations the site was inspected again and the underfloor area briefly investigated. In the area roughly corresponding with the patch in the ceiling marking a former chimney was a square concrete fireplace foundation 1200 x 1250 mm (see Figure 5). The fireplace base had been demolished to below the level of the floor joists and was constructed of rough concrete containing large basalt rock inclusions, the same as the outside footing. The foundation did not extend to the edge of the outside footing and was inset 370 mm from the inside of the footing. There was no evidence of there having been an external brick chimney in the underfloor area or in the back wall of the cottage and so the fireplace must have been a freestanding range or stove with a metal flue chimney. When looking at Figure 5 it is clear that the fireplace foundation does not quite align with the current internal layout of the cottage (especially the section of replaced flooring), suggesting that this has also been modified over the years.

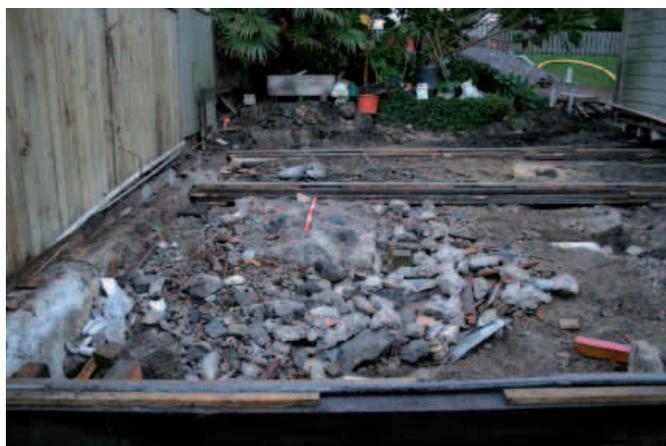
6 (top). View of the underfloor area immediately prior to investigation showing the concrete and basalt rubble from the fireplace base demolition. The 1 m scale is on the base of the fireplace foundation.

To further investigate the underfloor deposit an area was excavated from around the north and west side of the fireplace base and back to the inside edge of the west exterior footing. Over much of this area there was a layer of loose soil and rubble 50 – 70 mm deep containing artefactual and faunal material. Artefacts consisted of bottle glass, ceramics, a metal matchbox and footwear. Faunal material consisted of sawn and butchered animal bones and shell, including oyster, scallop, mussel, cockle and toheroa. A more unusual item was an exotic queen conch shell which was almost completely buried with just the distinctive knob-like spines on the shoulder of the shell protruding above the surface. Much of this material had been churned into a single homogenous deposit by rat burrowing.

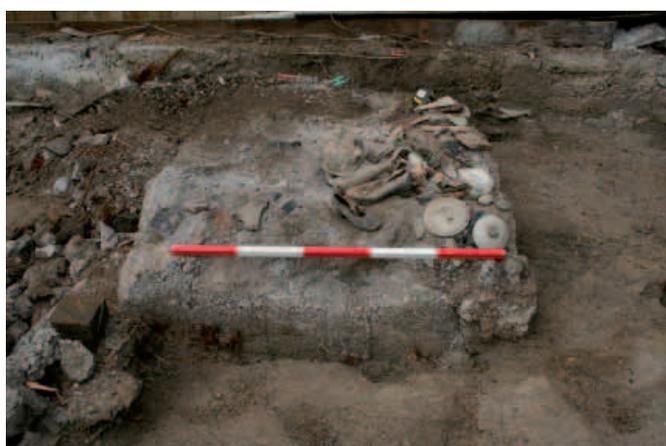
7 (bottom). The fireplace base after excavation showing the remnant wooden boxing along the north edge and various artefacts from the surrounding underfloor fill sitting on top (scale 1 m).
